USAAEFA PROJECT NO. 77-04

**ARMY PRELIMINARY EVALUATION
YAH-1S HELICOPTER WITH MODIFIED
FLAT PLATE CANOPY INSTALLED**

FINAL REPORT

UNITED STATES ARMY AVIATION ENGINEERING FLIGHT ACTIVITY
EDWARDS AIR FORCE BASE, CALIFORNIA 93523

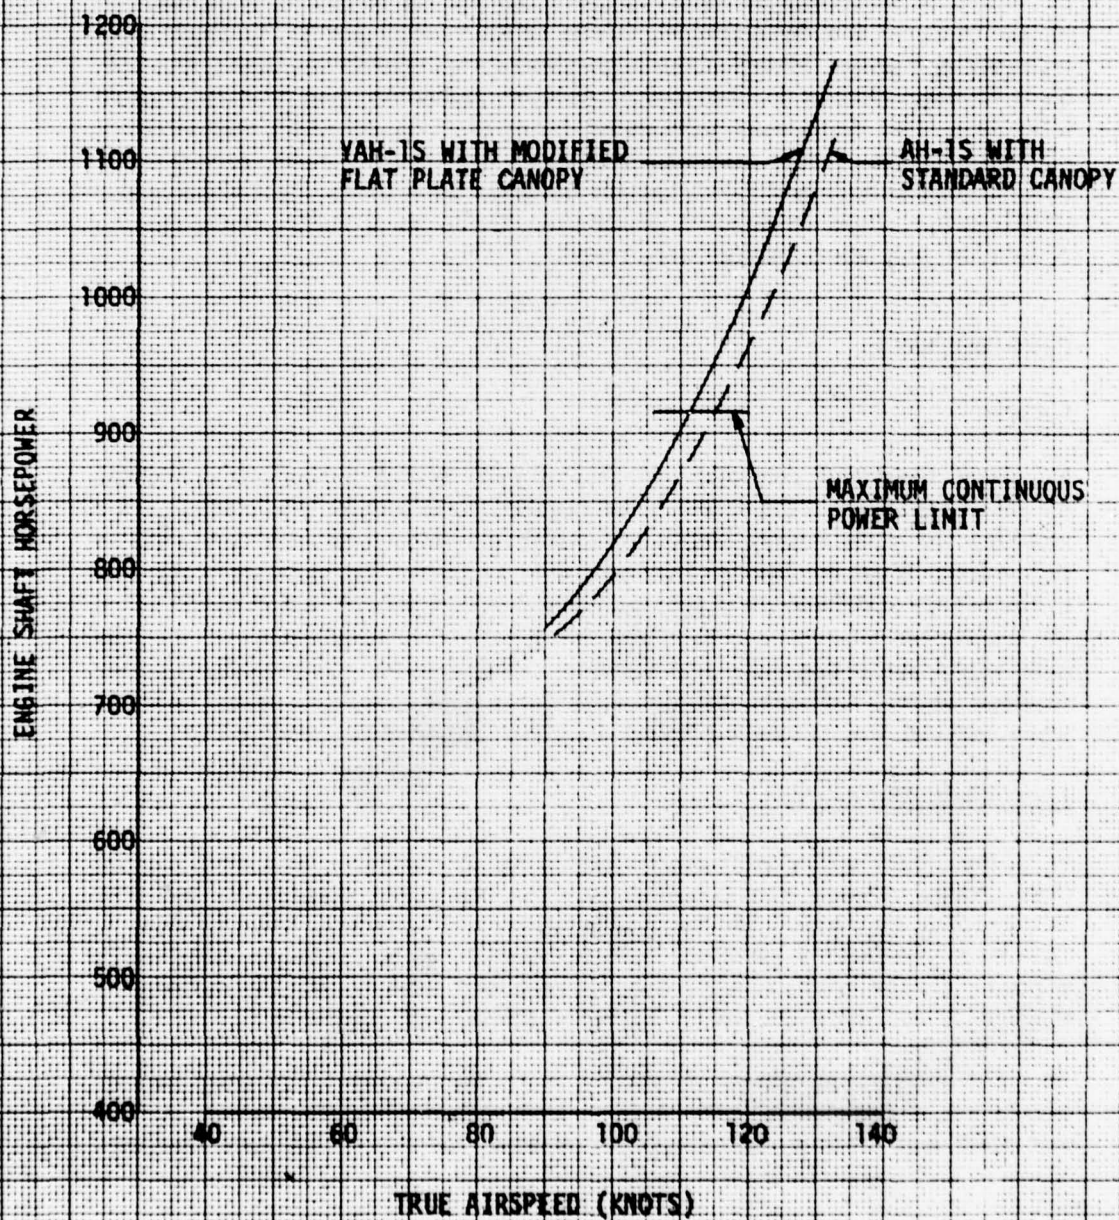
FIGURE A. LEVEL FLIGHT PERFORMANCE COMPARISON

GROSS WEIGHT (LB)	PRESSURE ALTITUDE (FT)	AIR TEMPERATURE (°C)	ROTOR SPEED (RPM)	CONFIGURATION
10000	4000	35	324	CLEAN/B-840 ROTOR/FWD CG

a standard canopy was obtained by extracting power required in level flight for the clean configuration from the AH-1G performance report (ref 13, app A) and adding the drag effects of a TOW missile sight installation (approximately 2.6 ft² per BHT). A clean configuration was utilized for comparison to better enable determination of the effect of the modified flat plate canopy on level flight performance. The Δf_e due to the modified flat plate canopy installation is approximately 3 ft² when calculated at airspeeds above 90 KTAS. This relates to a reduction in maximum airspeed for level flight (V_H) at maximum continuous power (MCP) of approximately 4 knots.

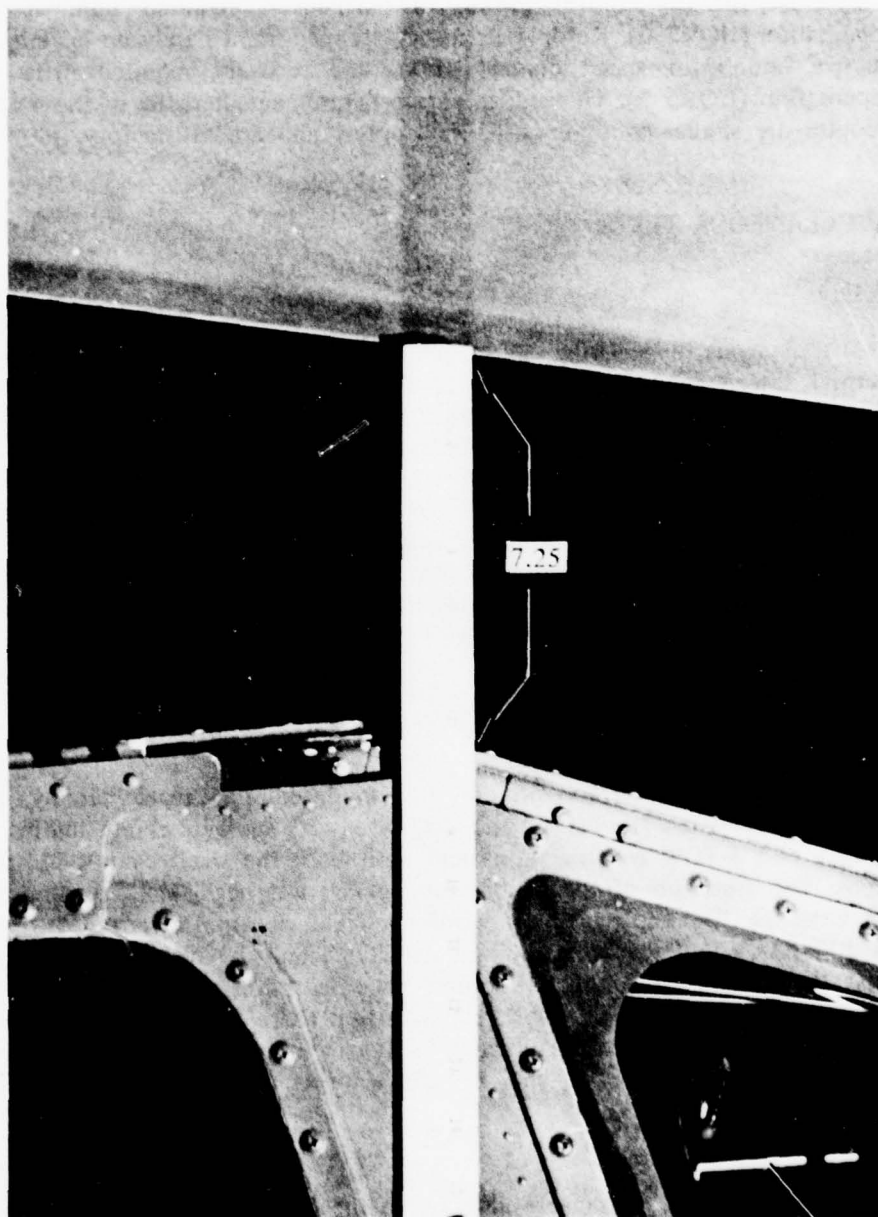
Photo A. K-747 Rotor to Canopy Clearance

44. A static fuselage clearance evaluation of the K-747 rotor was conducted at a maximum blade flapping angle of 12.25 degrees with no bending loads applied to the main rotor blades. Minimum canopy clearance occurred with full-up collective pitch and full-right cyclic and resulted in a clearance of 7.25 inches (photo A). A fuselage static interference was encountered at the top aft section of the upper pylon fairing (doghouse) with various combinations of cyclic and collective control

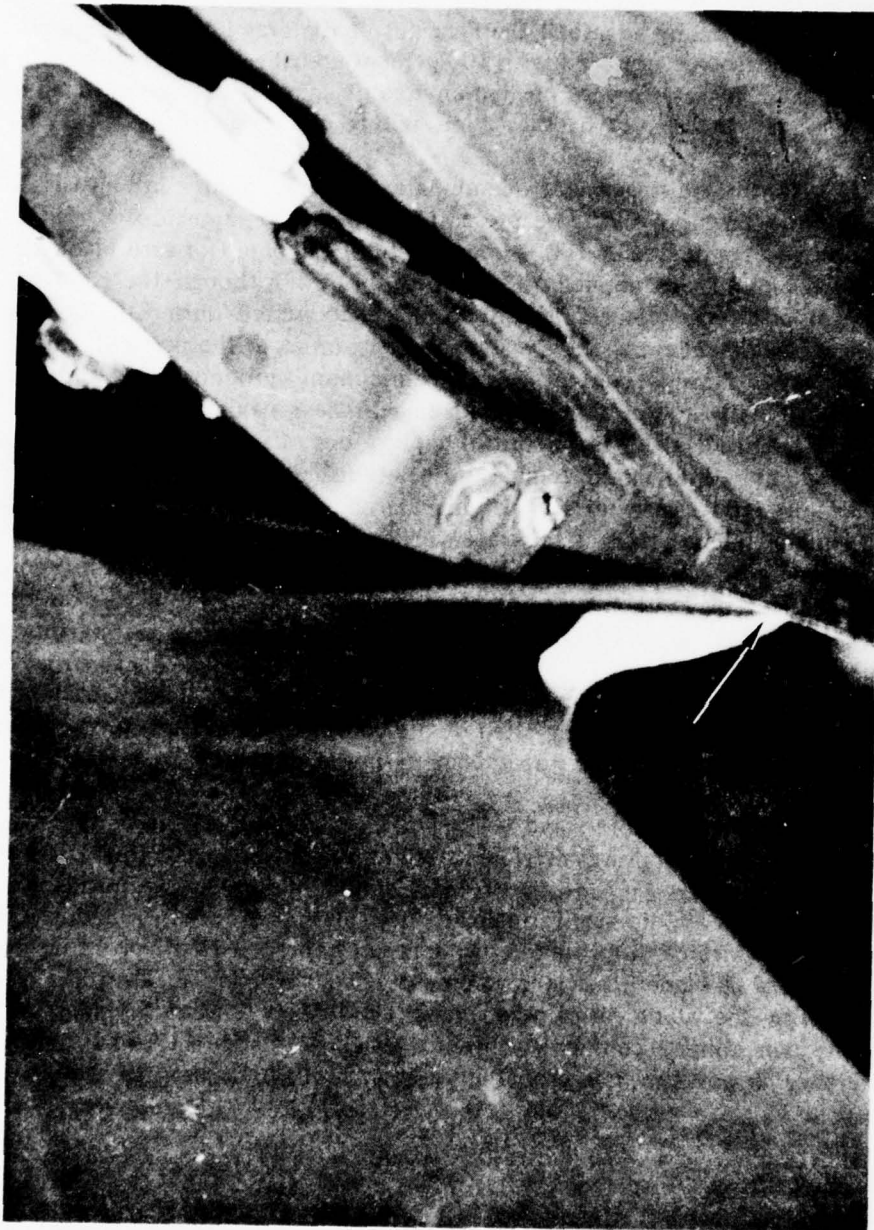
Photo B. K-747 Rotor to Pylon Fairing Interference

positions (photo B). The initial points of contact on the blades were the inboard 9 inches of the trailing edge and the lock nut of the drag link retaining bolt. The maximum interference occurred with 100 percent up-collective in combination with left aft cyclic. The interference created an area of contact that extended 20 inches forward of the trailing tip of the pylon fairing and to a depth of 2.25 inches.

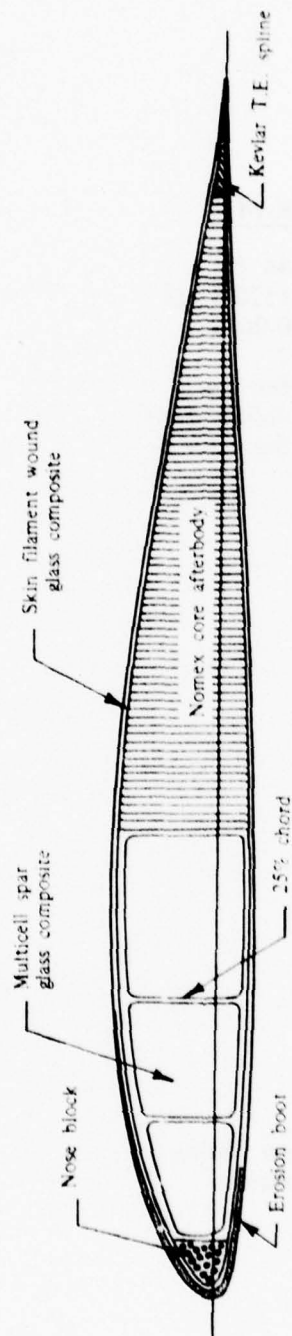
Figure 3. K-747 Blade Cross-Section Structural Arrangement.

Stations 66 through 177.4

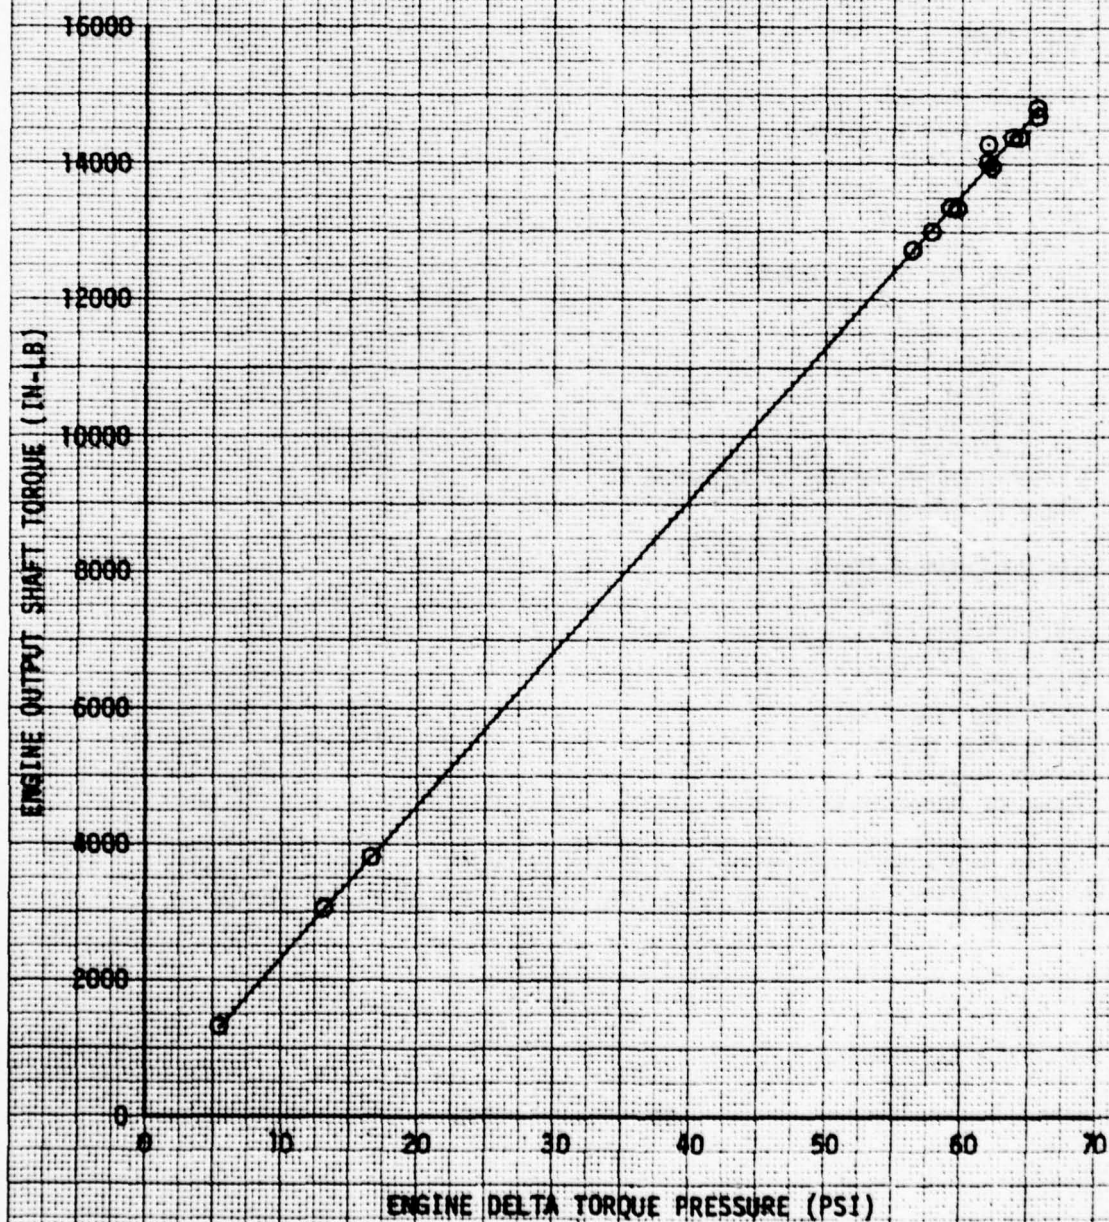
FIGURE 1
ENGINE TORQUEMETER CALIBRATION
Y53-L-703 S/N LE 152642

NOTE: POINTS OBTAINED FROM ENGINE ACCEPTANCE
TEST CONDUCTED 9 DEC 1975.

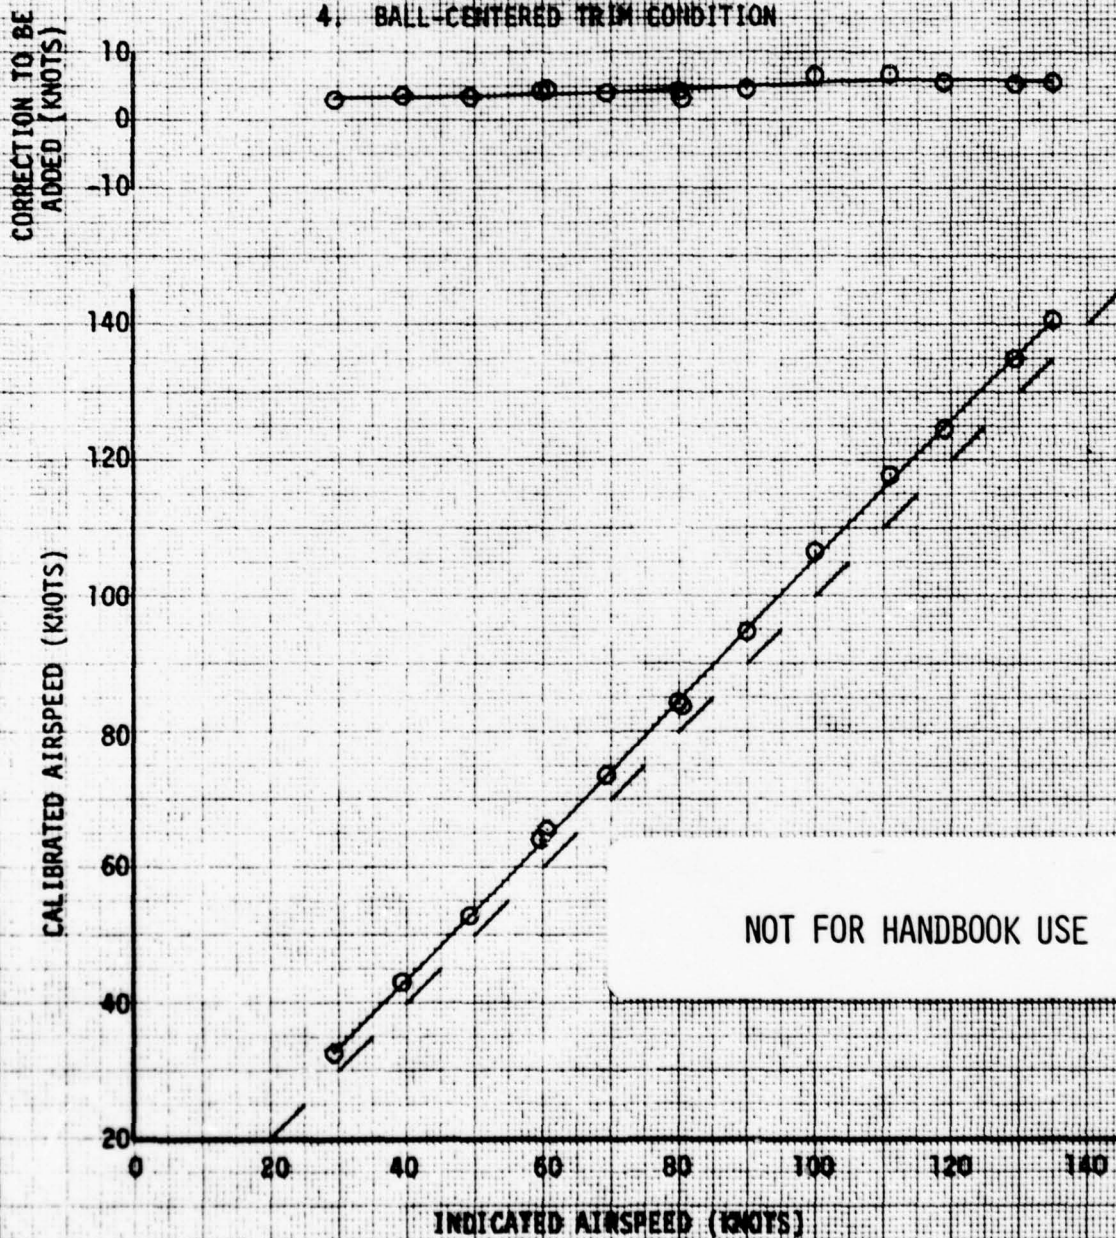
FIGURE 2
AIRSPEED CALIBRATION BOOM SYSTEM
YAH-1S USA S/N 70-16019

AVG GROSS WEIGHT (LB)	AVG CG LOCATION		AVG DENSITY ALTITUDE (FT)	AVG OAT (°C)	AVG ROTOR SPEED (RPM)	CONFIGURATION
LONG (IN.)	LAT (IN.)					
8320	199.8(AFT)	2 RT	5220	11.5	324	CLEAN

- NOTES: 1. DATA OBTAINED IN LEVEL FLIGHT
2. PACE METHOD UTILIZED
3. K-747 ROTOR INSTALLED
4. BALL-CENTERED TRIM CONDITION

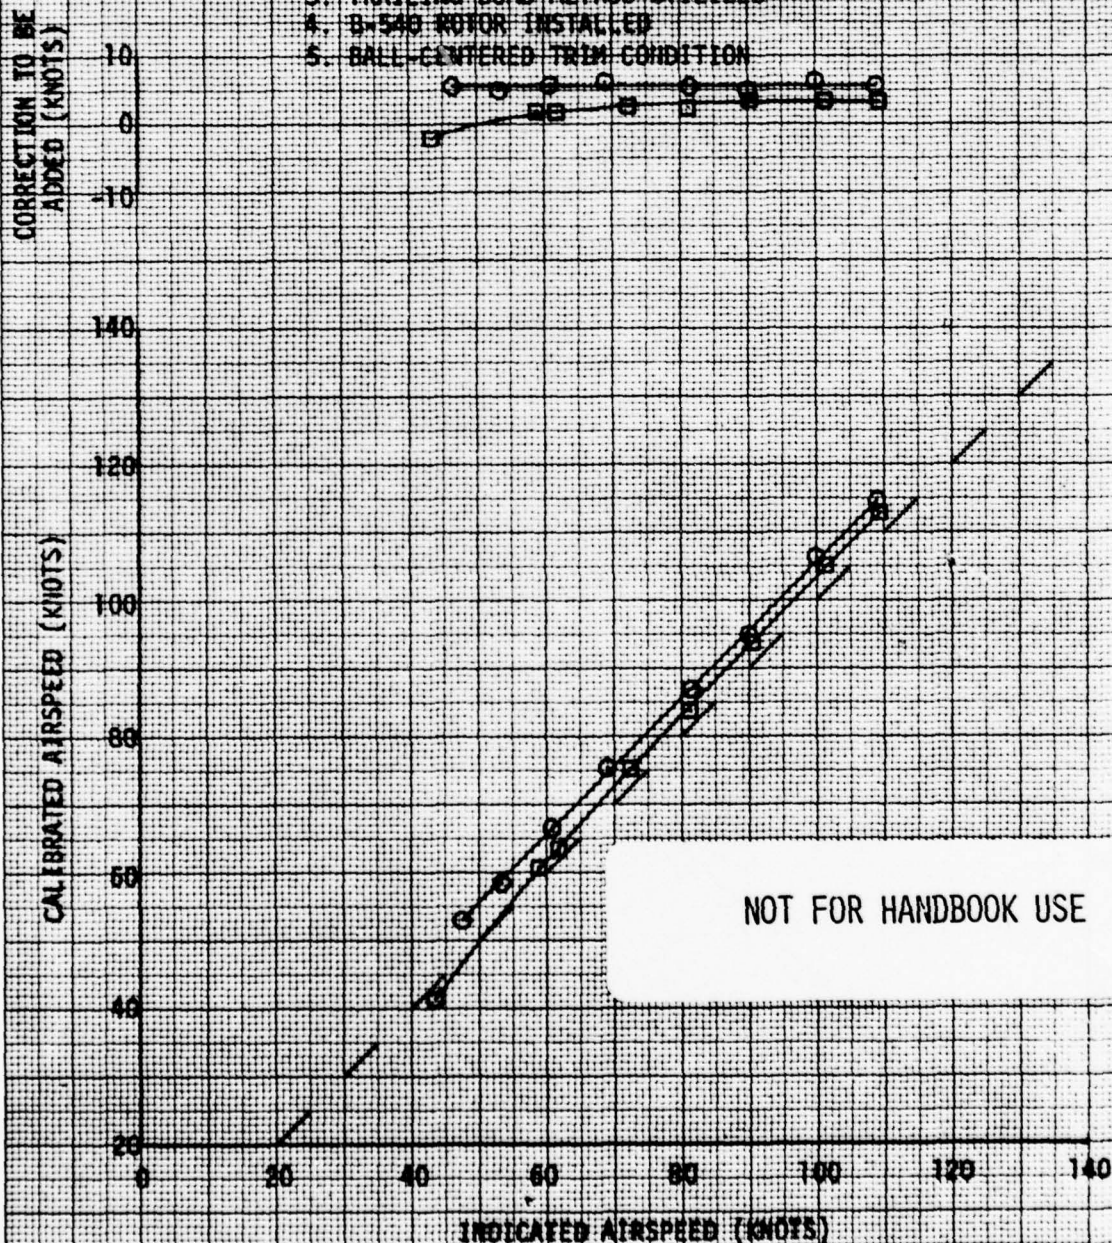
FIGURE 3
AIRSPEED CALIBRATION BOOM SYSTEM
YAH-15 USA S/N 70-16019

Avg Gross Weight (lb)	Avg CG Location		Avg Density Altitude (ft)	Avg OAT (°C)	Avg Rotor Speed (RPM)	Configuration
9340	Long (in.)	Lat (in.)				
	192.2 (FWD)	2 RT	5020	10.5	324	8-TOW

- NOTES: 1. ○ DATA OBTAINED IN CLIMBING FLIGHT
 2. □ DATA OBTAINED IN AUTOROTATIONAL FLIGHT
 3. TRAILING BOMB METHOD UTILIZED
 4. B-540 ROTOR INSTALLED
 5. BALL-CENTERED TRIM CONDITION

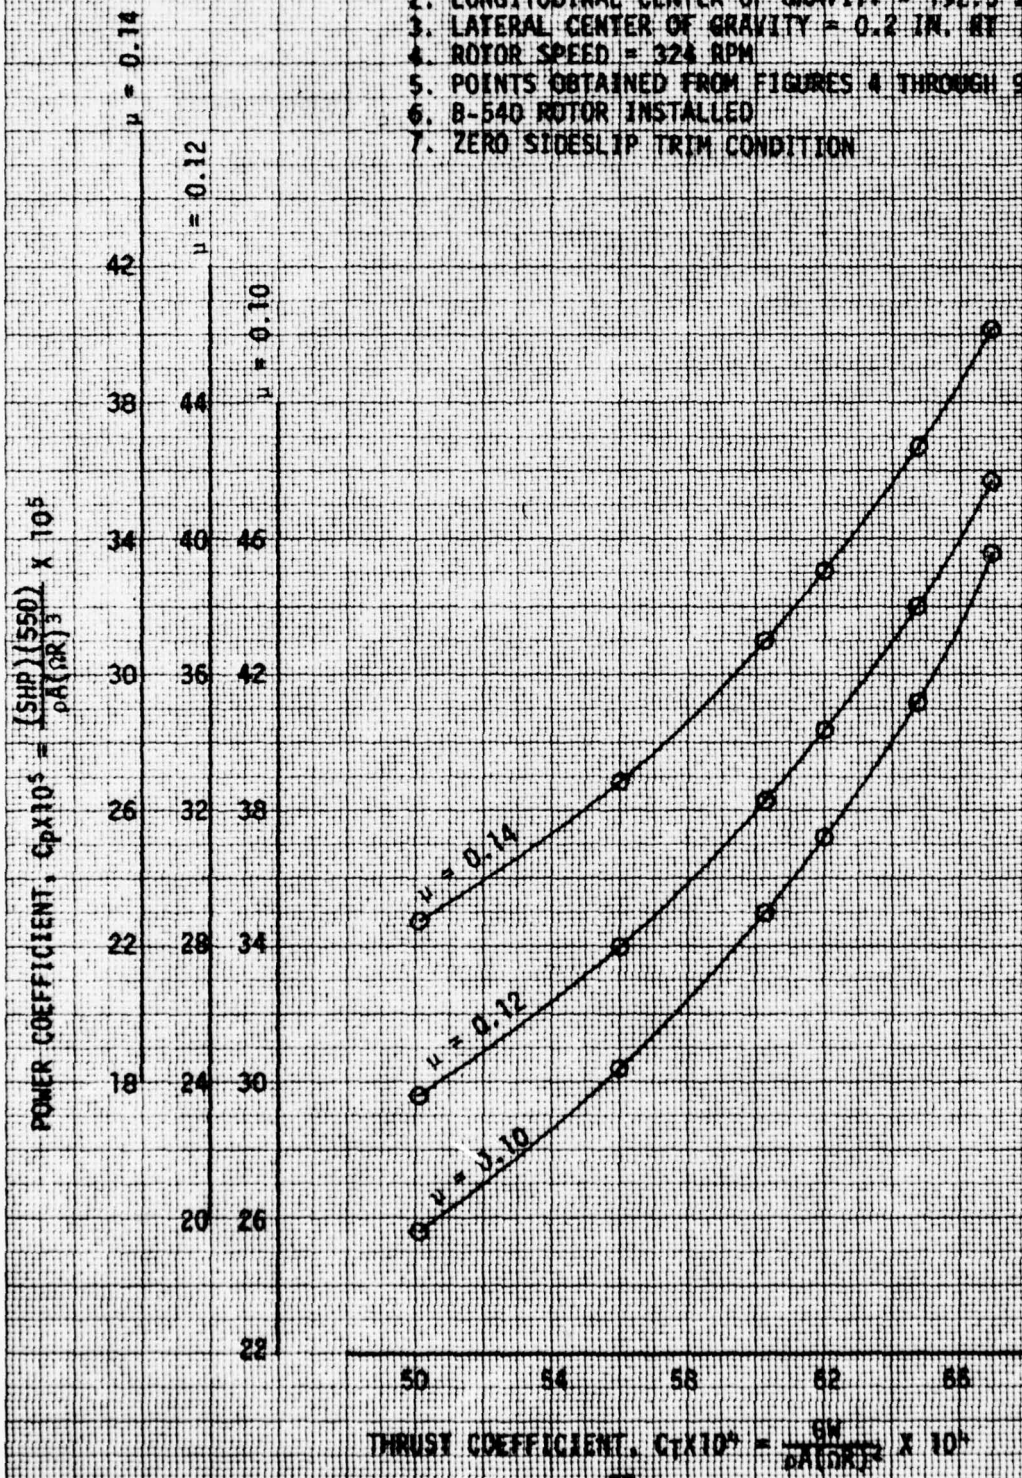
FIGURE 1
 NONDIMENSIONAL LEVEL FLIGHT PERFORMANCE
 YAH-15 USA S/N 70-16019

- NOTES: 1. 8-FOW CONFIGURATION
 2. LONGITUDINAL CENTER OF GRAVITY = 192.5 IN. (FWD)
 3. LATERAL CENTER OF GRAVITY = 0.2 IN. RT
 4. ROTOR SPEED = 324 RPM
 5. POINTS OBTAINED FROM FIGURES 4 THROUGH 9
 6. B-54D ROTOR INSTALLED
 7. ZERO SIDESLIP TRIM CONDITION

9. Level flight performance tests of the YAH-1S helicopter with modified flat plate canopy installed were conducted to determine power required and fuel flow as a function of airspeed for the configurations and conditions listed in table 1. Data were obtained in stabilized level flight utilizing the technique described in appendix D. The results of these tests are presented nondimensionally in figures 1 through 3, and dimensionally in figures 4 through 13, appendix E.

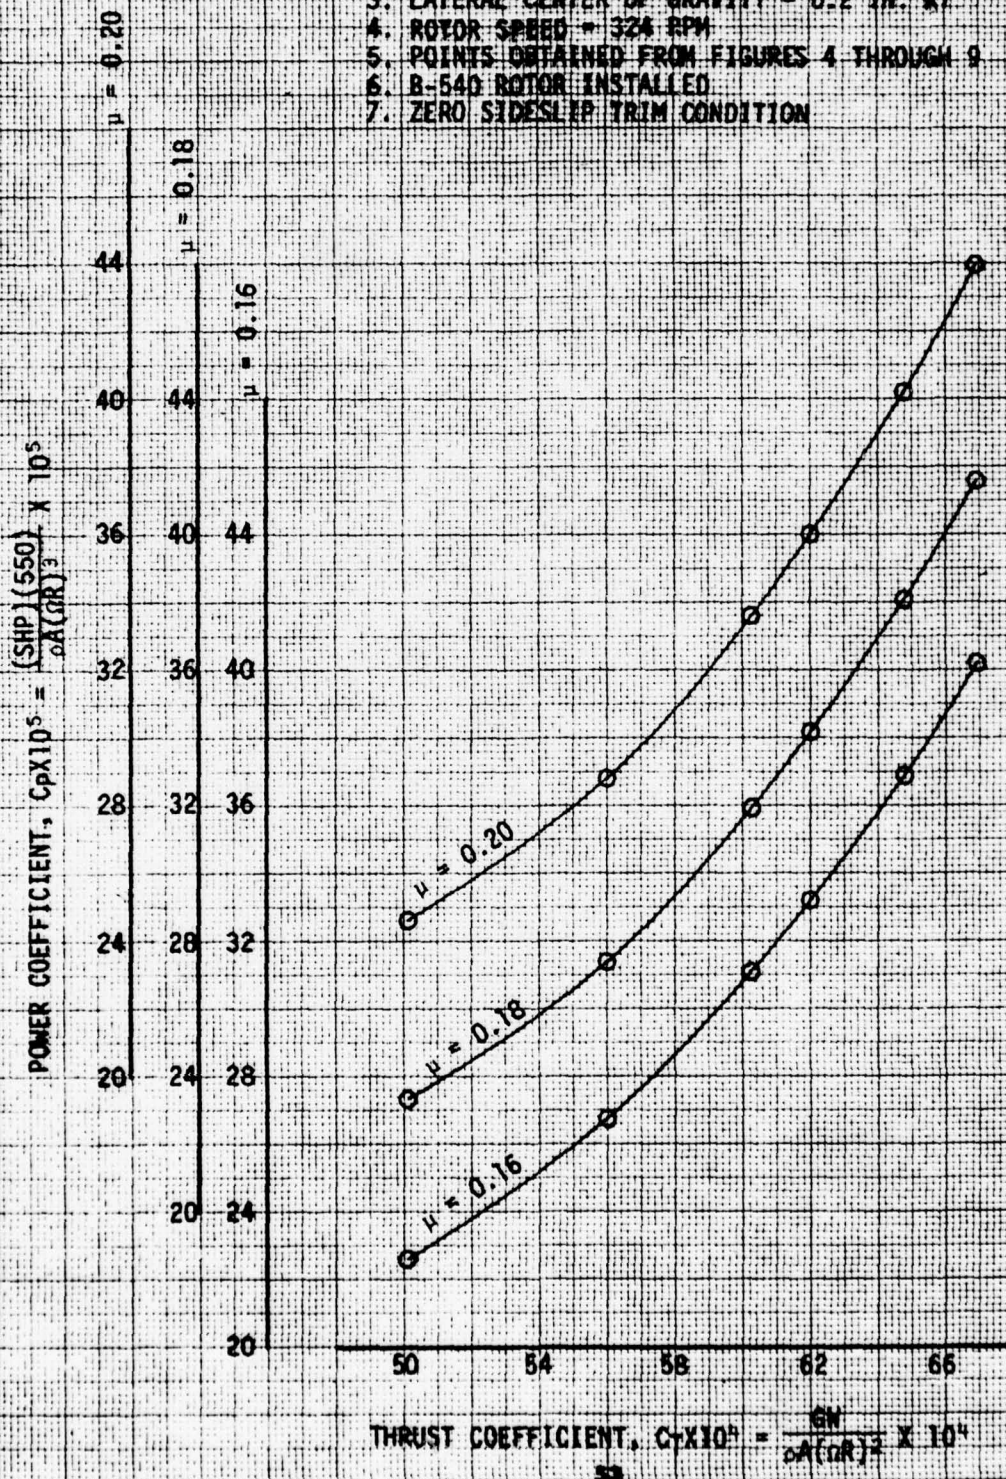
FIGURE 2
 NONDIMENSIONAL LEVEL FLIGHT PERFORMANCE
 YAH-15 USA S/N 70-16019

- NOTES: 1. 8-TOW CONFIGURATION
 2. LONGITUDINAL CENTER OF GRAVITY = 192.5 IN. (FWD)
 3. LATERAL CENTER OF GRAVITY = 0.2 IN. RT
 4. ROTOR SPEED = 324 RPM
 5. POINTS OBTAINED FROM FIGURES 4 THROUGH 9
 6. B-540 ROTOR INSTALLED
 7. ZERO SIDESLIP TRIM CONDITION

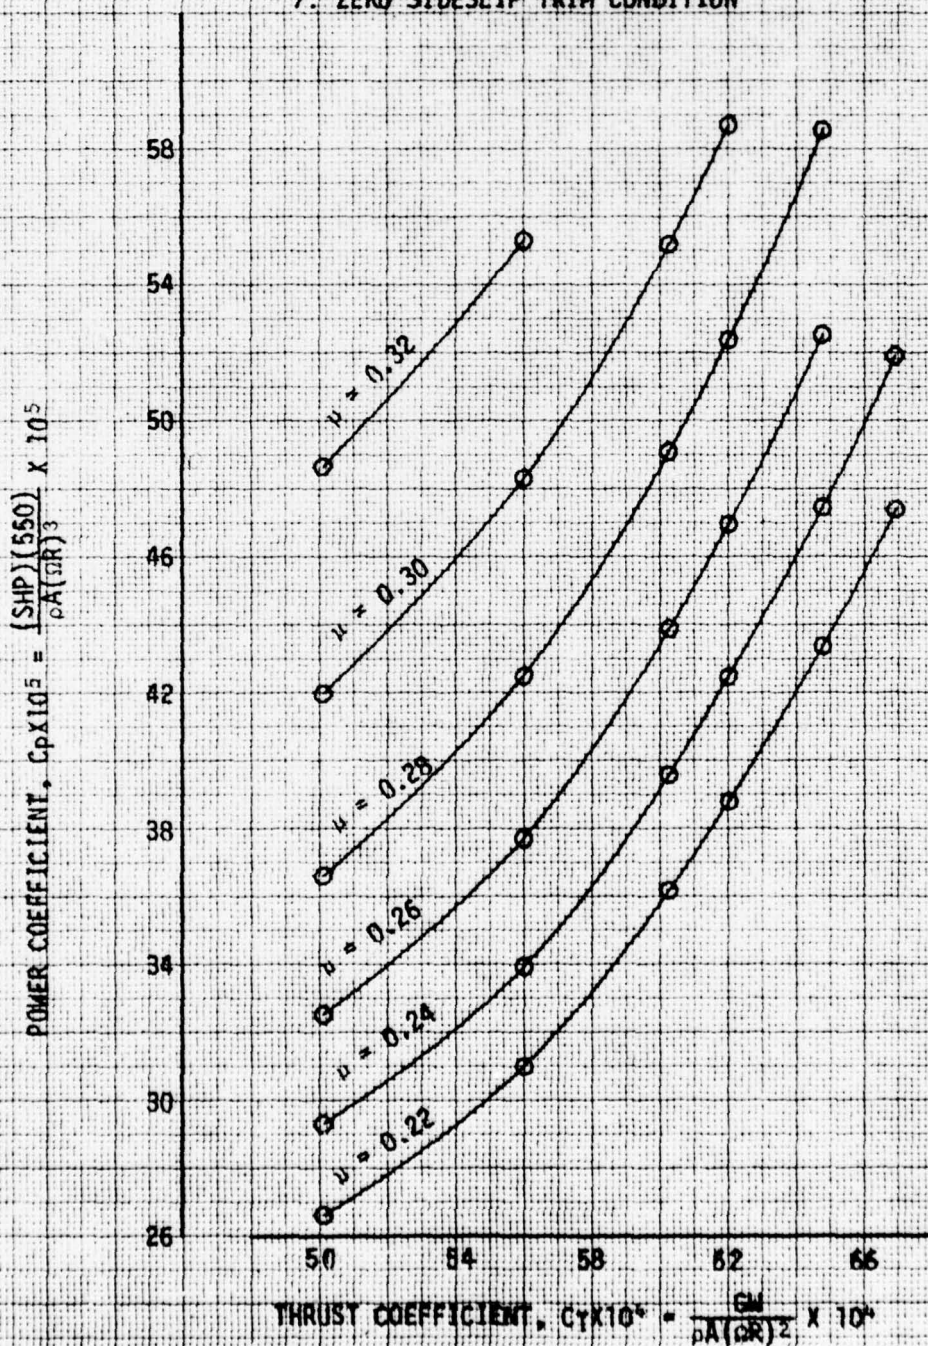
FIGURE 3
 NONDIMENSIONAL LEVEL FLIGHT PERFORMANCE
 YAH-1S USA S/N 70-16019

- NOTES:
1. 8-TOW CONFIGURATION
 2. LONGITUDINAL CENTER OF GRAVITY = 192.5 IN. (FWD)
 3. LATERAL CENTER OF GRAVITY = 0.2 IN. RT
 4. ROTOR SPEED = 324 RPM
 5. POINTS OBTAINED FROM FIGURES 4 THROUGH 9
 6. B-540 ROTOR INSTALLED
 7. ZERO SIDESLIP TRIM CONDITION

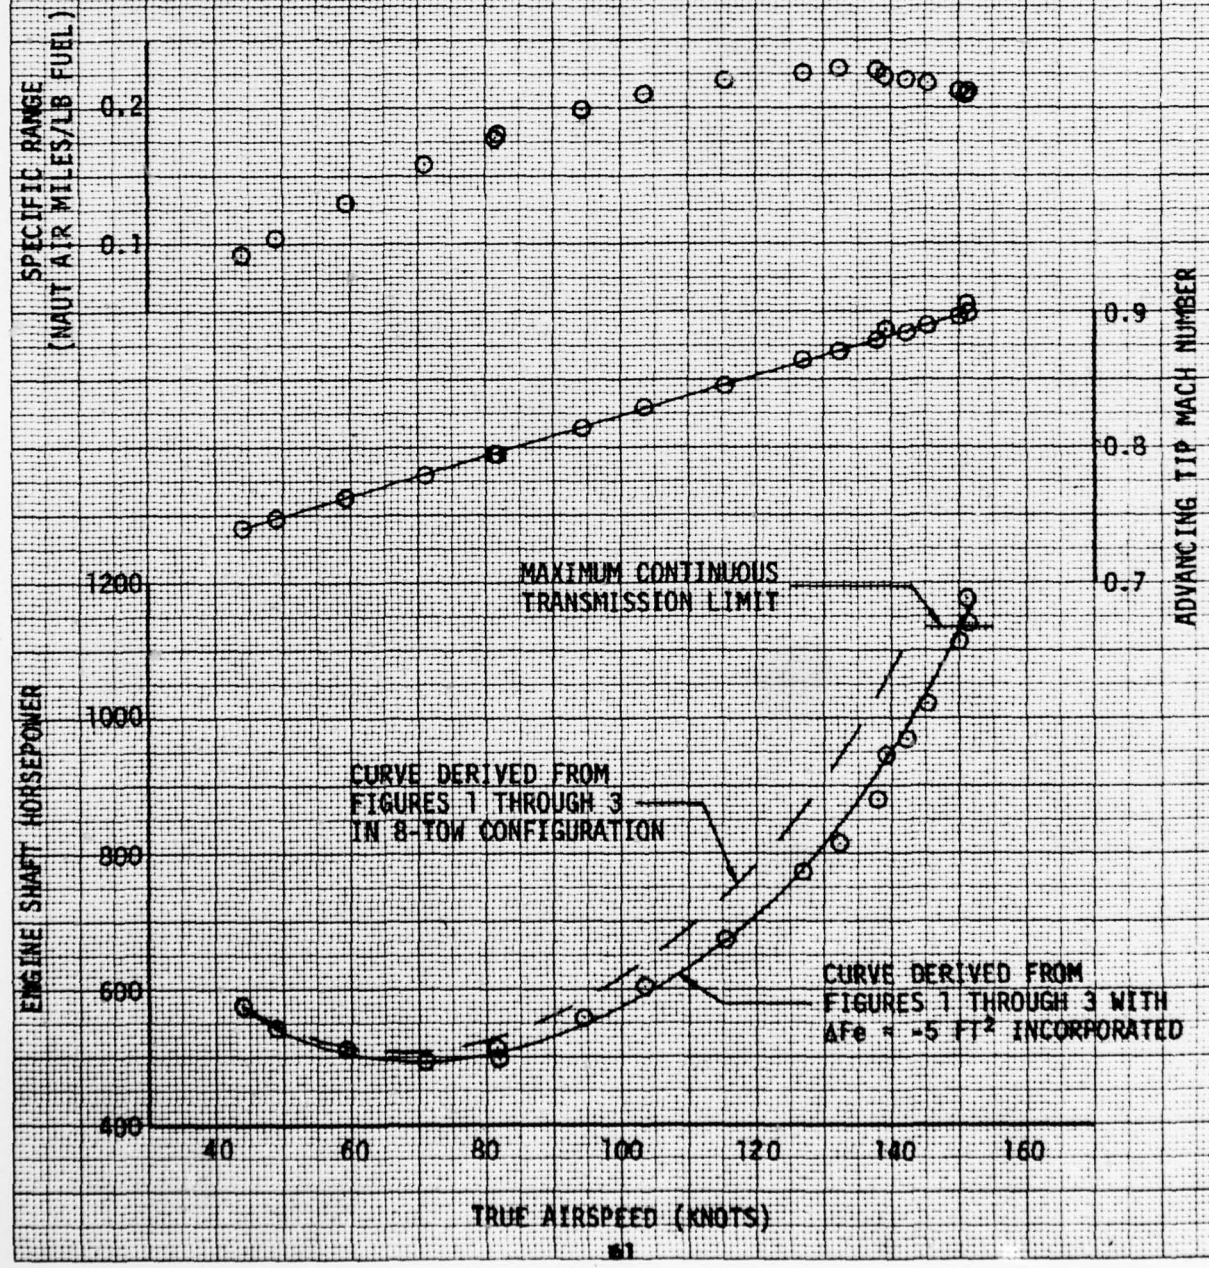
FIGURE 10
LEVEL FLIGHT PERFORMANCE
YAH-1S USA S/N 70-16019

AVG GROSS WEIGHT (LB)	AVG CG LOCATION		AVG DENSITY ALTITUDE (FT)	AVG OAT (°C)	AVG ROTOR SPEED (RPM)	AVG C_T	CONFIGURATION
	LONG (IN.)	LAT (IN.)					
8320	192.6(FWD)	0.2 RT	6400	13.0	324	0.005003	CLEAN

NOTES: 1. B-540 ROTOR INSTALLED
2. ZERO SIDESLIP TRIM CONDITION

11. The comparison between external stores configurations for the YAH-1S modified flat plate canopy is presented in figures 10 and 11, appendix E. The comparison of cg configurations is presented in figures 12 and 13. Test results indicate that the effective Δf_e of an 8-TOW configuration was 5 ft². This differs from the 6.5 ft² stated in the AH-1S operator's manual (ref 4, app A). Changing the longitudinal cg location appears to have little effect on power required for level flight. Test data show that for a 7-inch change in cg, Δf_e was only 1 ft². This represents a marked reduction in Δf_e with Δcg when compared to the AH-1G (ref 14, app A).

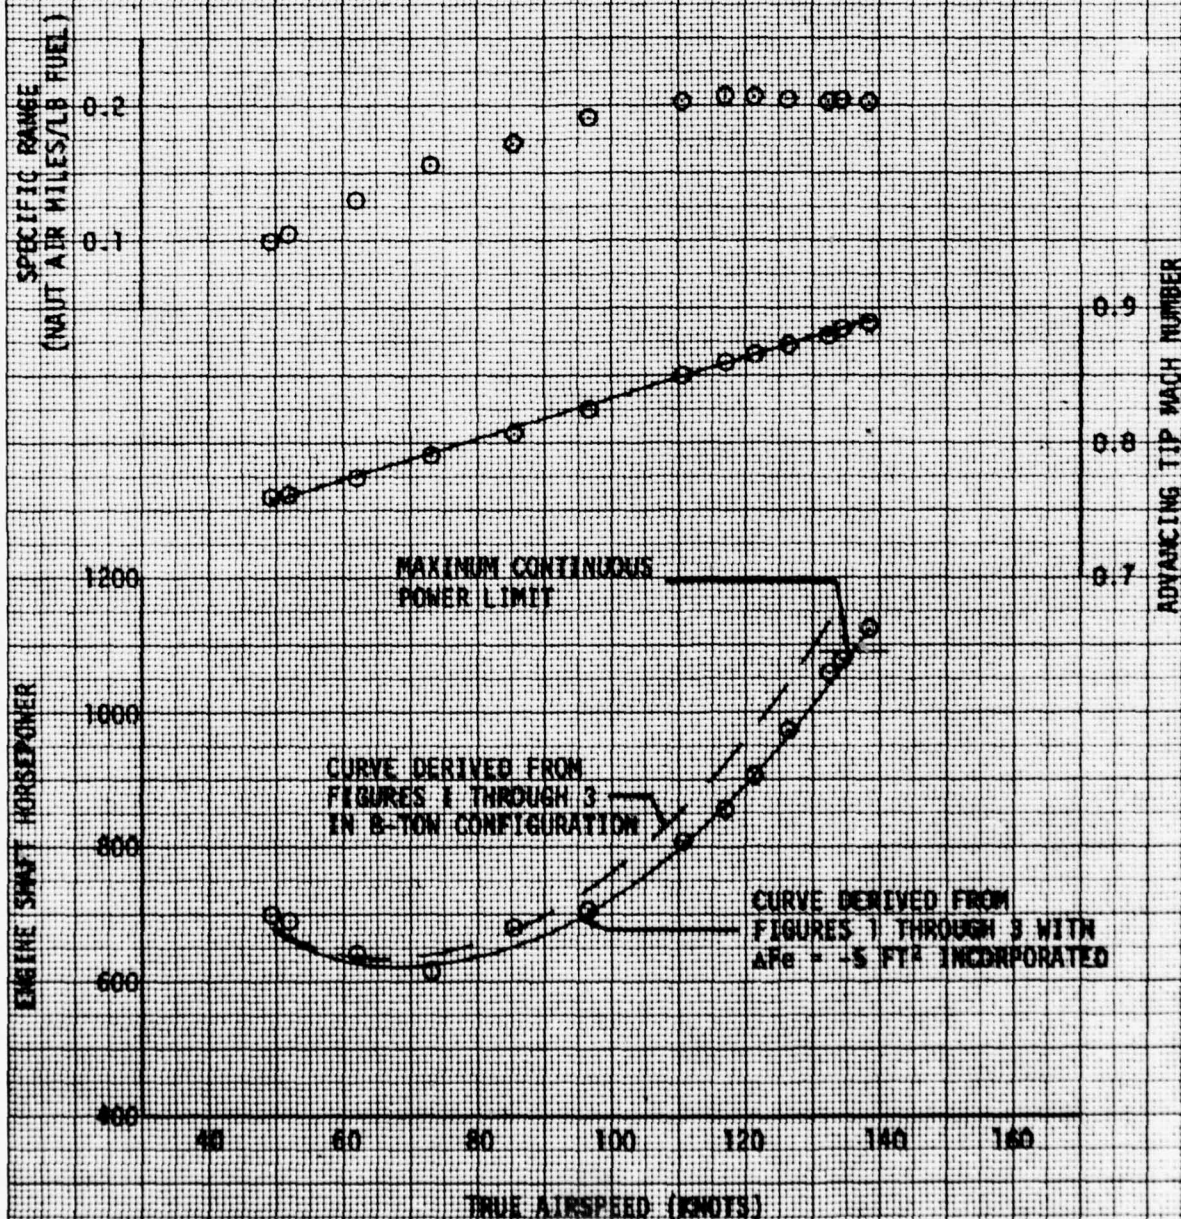
FIGURE 11
LEVEL FLIGHT PERFORMANCE
YAM-15 USA S/N 70-16019

AVG GROSS WEIGHT (LB)	AVG CG LOCATION		AVG DENSITY ALTITUDE (FT)	AVG OAT (°C)	AVG ROTOR SPEED (RPM)	AVG C _T	CONFIGURATION
LONG (IN.)	LAT (IN.)						
9140	192.6 (FWD)	0.2 RT	9280	5.5	324	0.006010	CLEAN

NOTES: 1. B-540 ROTOR INSTALLED
2. ZERO SIDESLIP TRIM CONDITION

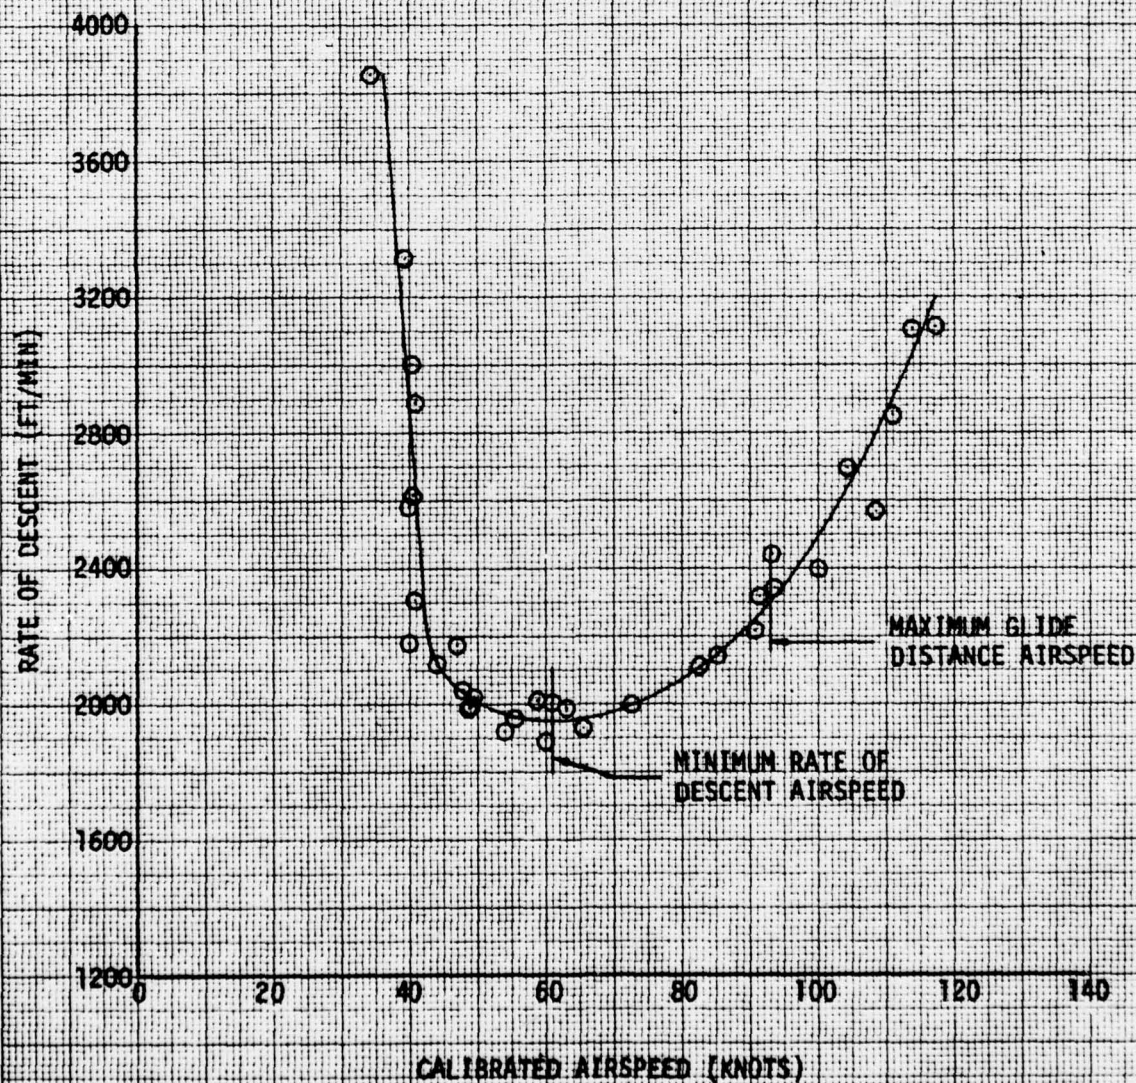
FIGURE 14
AUTOROTATIONAL DESCENT PERFORMANCE
 YAH-15 USA S/N 70-16019

AVG GROSS WEIGHT (LB)	AVG CG LOCATION		AVG DENSITY ALTITUDE (FT)	AVG OAT (°C)	AVG ROTOR SPEED (RPM)	AVG C_T	CONFIGURATION
9760	LONG (IN.)	LAT (IN.)					
	192.5(FWD)	0.2 RT	5000	11.0	324	0.005625	8-TON

NOTES: 1. B-540 ROTOR INSTALLED
 2. ZERO SIDESLIP TRIM CONDITION

12. Autorotational descent performance was evaluated in the 8-TOW configuration with the B-540 rotor system at the conditions listed in table 1. The tests were flown at an average rotor speed of 324 rpm and zero sideslip, using the technique described in appendix D. Test results are presented in figure 14, appendix E.

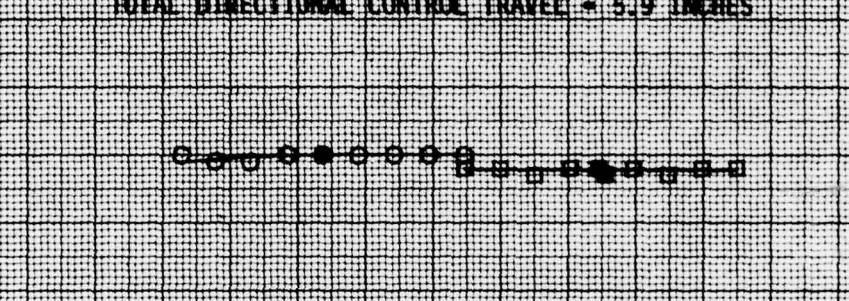
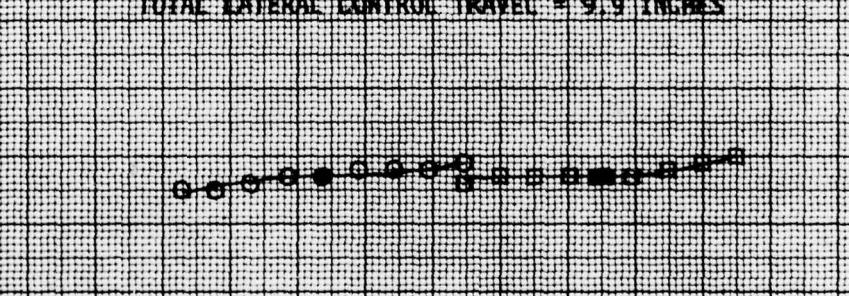
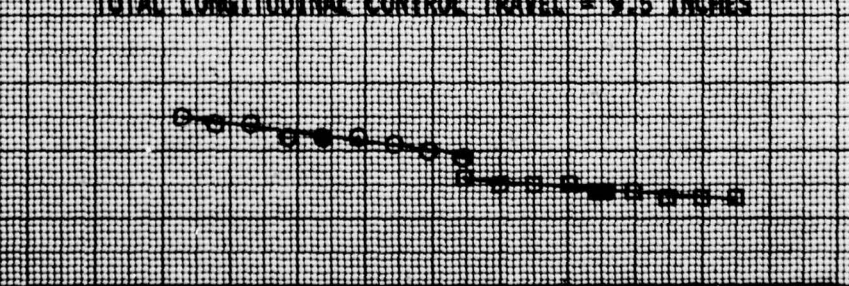
FIGURE 17
COLLECTIVE-FIXED STATIC LONGITUDINAL STABILITY
YAM-15 USA S/N 70-16019

SYM	AVG GROSS WEIGHT (LB)	AVG CG LOCATION		AVG DENSITY ALTITUDE (FT)	AVG OAT (°C)	AVG ROTOR SPEED (RPM)	CONFIGURATION
		LONG (IN.)	LAT (IN.)				
0 0	9240	199.7 (ART)	0.2 RT	5020	17.5	324	8-TON
0 0	9580	199.8 (ART)	0.2 RT	4840	17.0	324	8-TON

21. Collective-fixed static longitudinal stability was evaluated at the conditions listed in table 1, using the test technique described in appendix D. Test results are presented in figure 17, appendix E.

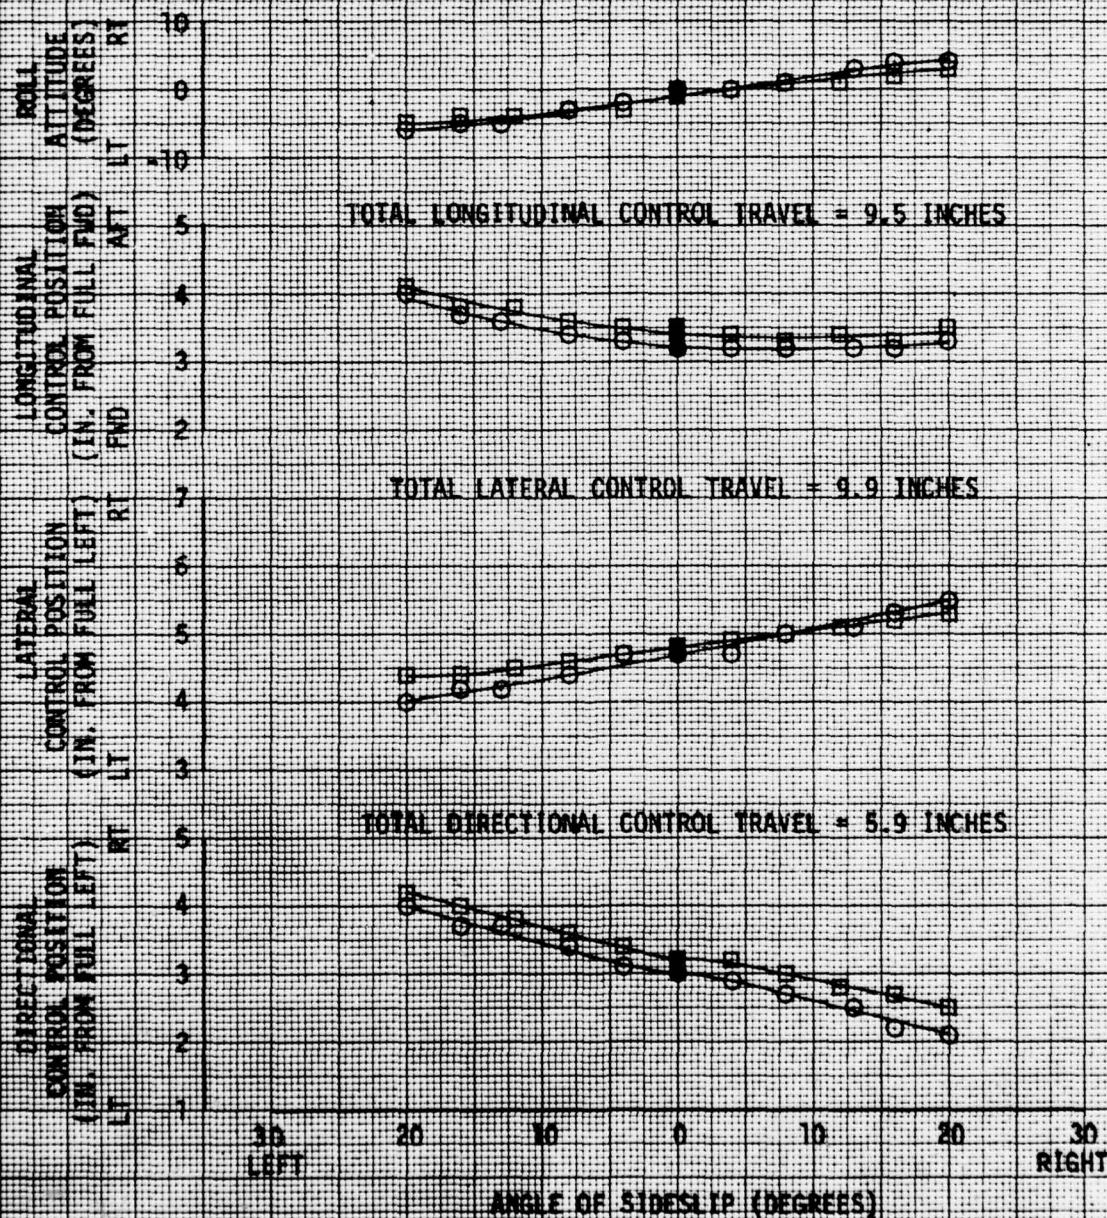
FIGURE 18
STATIC LATERAL-DIRECTIONAL STABILITY
YAH-15 USA S/N 70-18019

SYM	AVG GROSS WEIGHT (LB)	AVG CG LOCATION LONG (IN.)	AVG CG LOCATION LAT (IN.)	AVG DENSITY ALTITUDE (FT)	AVG OAT (°C)	AVG ROTOR SPEED (RPM)	TRIM CALIBRATED AIRSPEED (KT)	CONFIGURATION
O	9120	199.7(AFT)	0.2 RT	5200	18.0	324	64	8-TOW
D	7800	199.4(AFT)	0.2 RT	4960	13.0	324	61	CLEAN

NOTES: 1. COLLECTIVE CONTROL POSITION HELD FIXED DURING TEST.
 2. SHADED SYMBOLS DENOTE LEVEL FLIGHT TRIM POINT.
 3. K-747 ROTOR INSTALLED.

24. Static lateral-directional stability characteristics were evaluated at the conditions listed in table 1, using the test technique described in appendix D. Test results are presented in figures 18 and 19, appendix E.

25. Static directional stability, as indicated by the variation of directional control position with sideslip, was positive (left pedal required to maintain right sideslip) at the airspeeds tested. Directional control variation with sideslip was shallow for sideslip angles of ± 4 degrees but increased significantly at greater sideslip angles. This variation also increased slightly with increased trim airspeed. There was essentially no change between the clean and 8-TOW configurations. Directional stability was qualitatively noted as being reduced from the AH-1G. Ball-centered flight and zero sideslip flight were difficult to maintain and there was a tendency for small, undamped yaw oscillation (± 3 degrees from trim). During simulated attack dives, considerable pilot effort was required to maintain coordinated (ball-centered) flight. The weak directional stability of the YAH-1S near trim is a shortcoming noted on other AH-1 series helicopters.

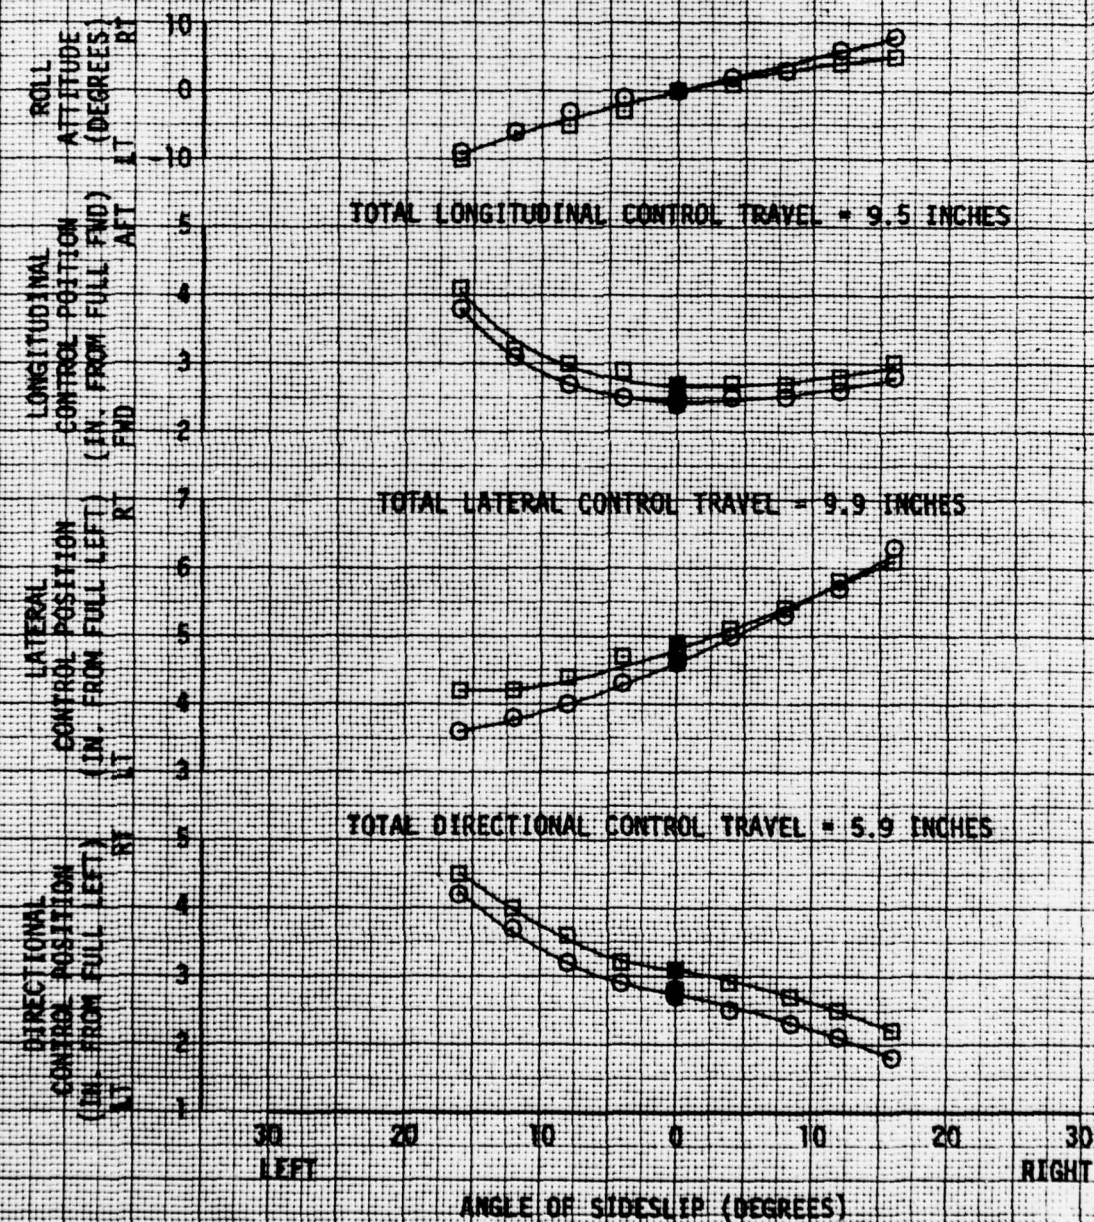
FIGURE 19
STATIC LATERAL-DIRECTIONAL STABILITY
YAH-15 USA S/N 70-16019

SYM	AVG GROSS WEIGHT	AVG CG LOCATION		AVG DENSITY ALTITUDE	AVG DAT	AVG ROTOR SPEED	TRIM CALIBRATED AIRSPEED	CONFIGURATION
	(LB)	LONG (IN.)	LAT (IN.)	(FT)	(%)	(RPM)	(KT)	
○	9440	199.8(AFT)	0.2 RT	4980	18.0	324	105	8-TOW
□	8040	199.5(AFT)	0.2 RT	4820	13.5	324	102	CLEAN

- NOTES: 1. COLLECTIVE CONTROL POSITION HELD FIXED DURING TEST.
 2. SHADED SYMBOLS DENOTE LEVEL FLIGHT TRIM POINT.
 3. K-747 ROTOR INSTALLED.

sideslip, were positive (left roll attitude required to maintain left sideslip). The roll attitude gradient increased with increased airspeed. The 8-TOW configuration exhibited slightly stronger side force than the clean configuration. During mission maneuvering tasks, considerable pilot compensation was required to maintain coordinated flight due to the weak directional stability and inadequate side-force cues (HQRS 5). Because of the nature of contour and NOE flight, the pilot's attention must be directed out of the cockpit. Uncoordinated flight was common during these types of maneuvers. The weak side-force characteristics of the YAH-1S are a shortcoming noted on other AH-1 series helicopters.
